GRANDE RONDE BASIN FISH HABITAT ENHANCEMENT PROJECT

1998 Annual Report

Oregon Department of Fish and Wildlife

Project Number 84-025-00
Contract Number DE-BI79-84BP16114

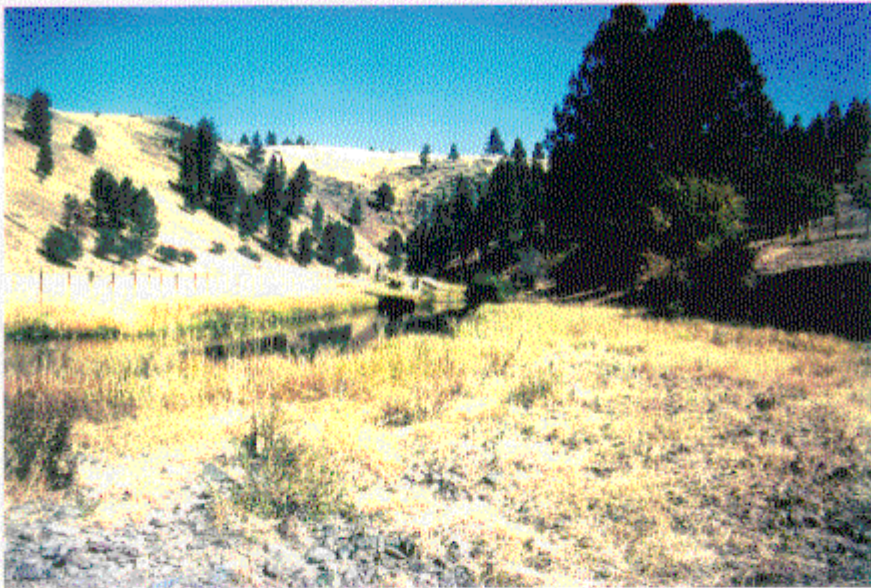
Photo #1: Pine Creek, McDaniel property, near the mouth, September 25, 1991. This stream had a serious overgrazing problem, and high bedload movement in this area. New fencing was completed in 1991 and is visible on the left bank. The landowner allowed for continued movement of the stream channel by providing a wide corridor on the right side of the stream (fence not visible).

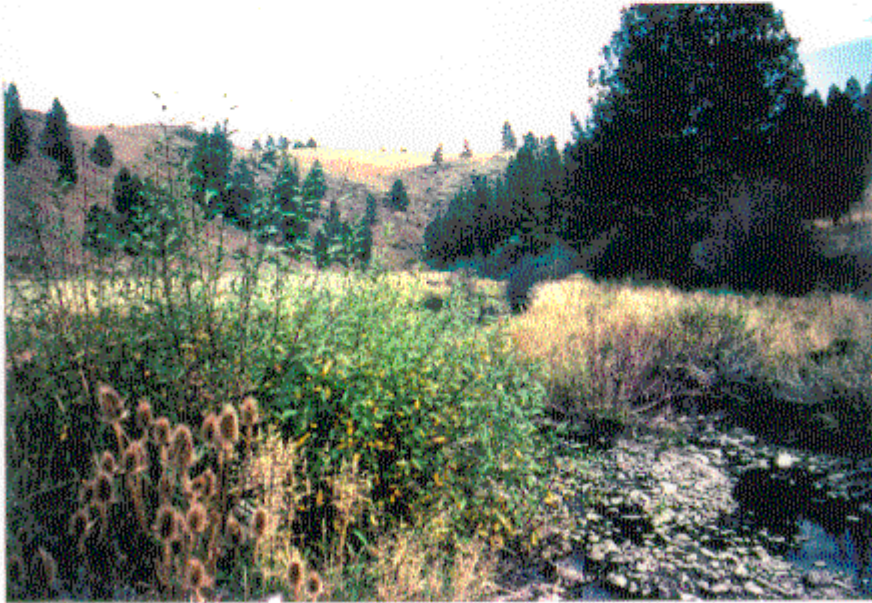
Photo #2: Pine Creek, McDaniel property, near the mouth, October 22, 1998. Despite heavy flooding in recent years, after seven years the stream is now lush with native riparian plants. Part of stream channel has migrated to the right side of the floodplain.

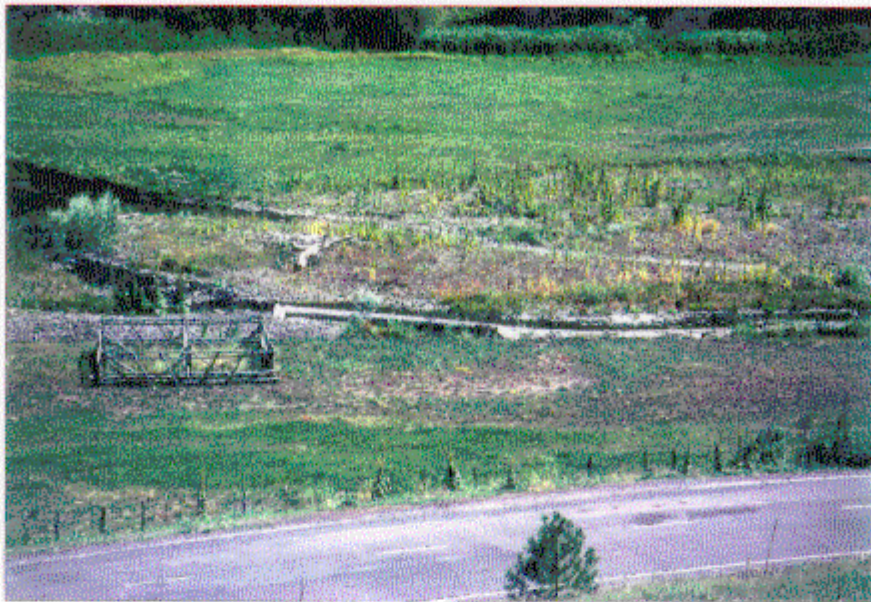
Photo #3: Chesnimnus Creek, McDaniel property, August 10, 1992. Prior to project implementation the stream channel was very unstable, with many exposed gravel bars due to excess erosion. Many areas were wide and shallow, with poor vegetation or shade. Instream work consisting of bank stabilization structures and additions of large wood was completed in 1991. Fencing and plantings were completed in 1992.

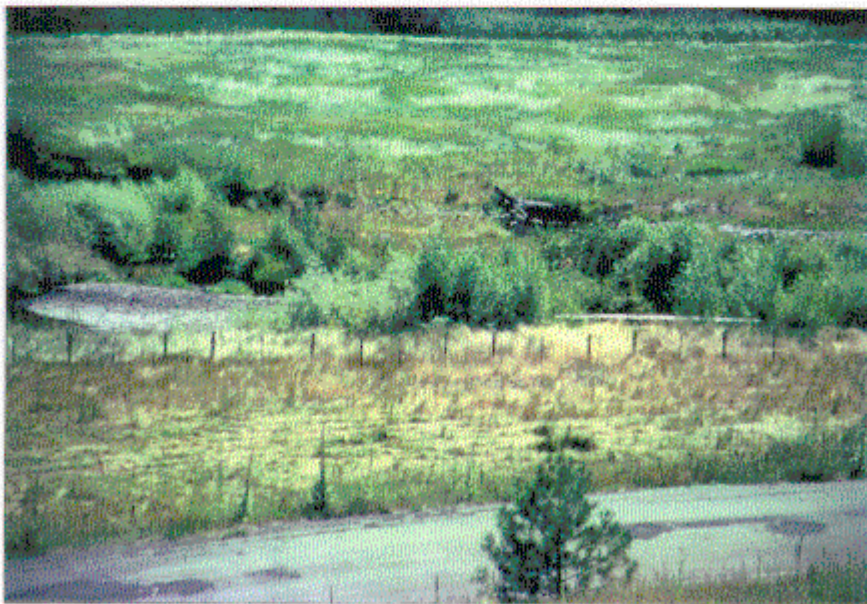
Photo #4: Chesnimnus Creek, McDaniel property, August 11, 1998. After only 6 years the stream channel is now well hidden with both native and planted willows. As with the Yost property downstream, this creek responded very quickly to rest from grazing.

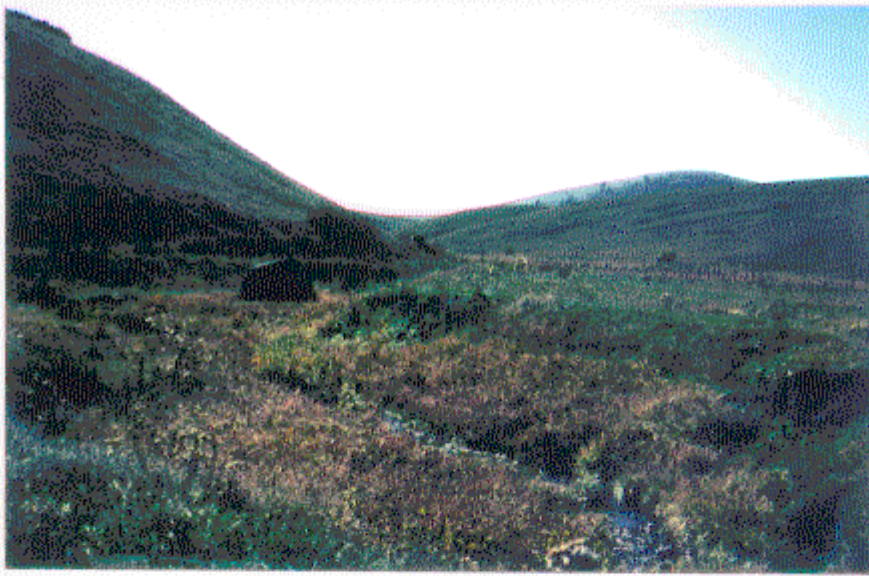
Photo #5: Salmon Creek, McClaran property, October 10, 1989. Fencing was installed in 1989, and is visible on the right bank. Some trees and shrubs were planted, but no instream work was conducted on this creek.

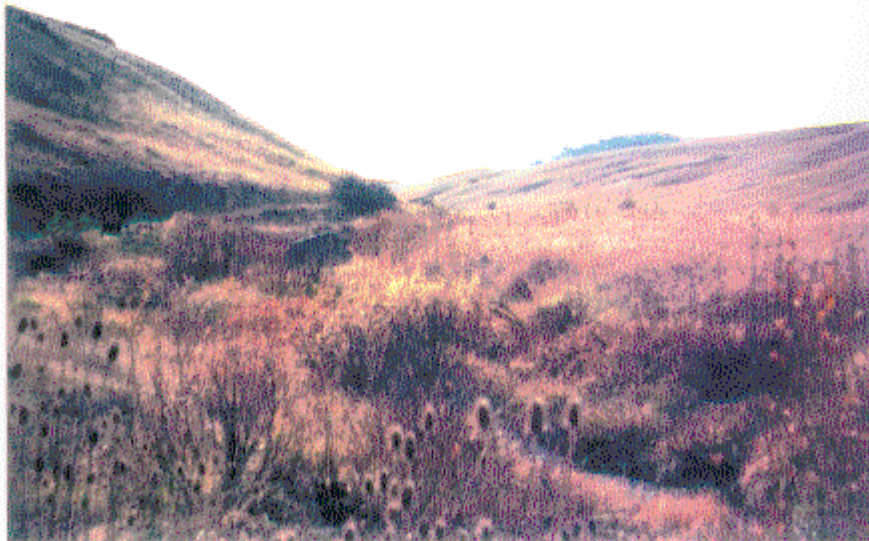
Photo #6: Salmon Creek, McClaran property, October 23, 1998. After 9 years of rest the stream is well shaded even in this fall picture; the large rock and fencing are barely visible. The channel has narrowed and deepened. Summer stream temperatures at this site (RM 0.1) are consistently 1.5 to 3.8 degrees Celsius cooler and fluctuate less than the upstream monitoring site at RM 2.4.

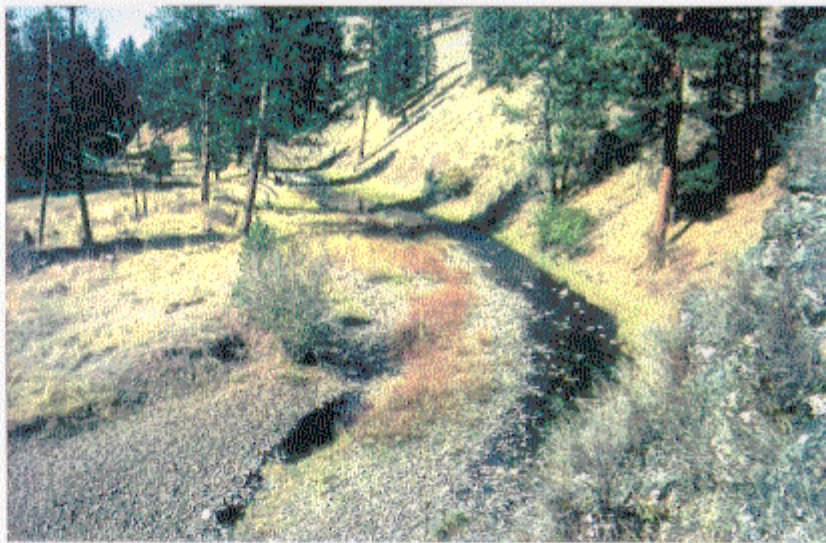
Photo #7-9: Meadow Creek, Alta Cunha Ranches property, August 4, 1999, pre-project photographs.

Stream temperatures were unusually hot this summer; the main channel to the right had lethal temperatures of 84°F at 3 p.m. However, pockets of cooler subsurface flow could be found such as occurred from this floodplain tail seep on the left.

Approximately 90 Rb/Si from 2.5 to 10 inches were able to locate this cold area, which was still in the stressful range of 72°F. Fish were congregated in a shallow 1 m² area with no cover, making them more susceptible to disease or predation from birds, mammals or reptiles.

Elevated temperatures can also impair swimming ability of salmonids. A pair of garter snakes was observed eating these fish, which were much easier to catch under these conditions. Fencing and instream work are planned for 1999, which we hope will improve conditions by creating more complex pool habitat and eventually reduce stream temperatures.

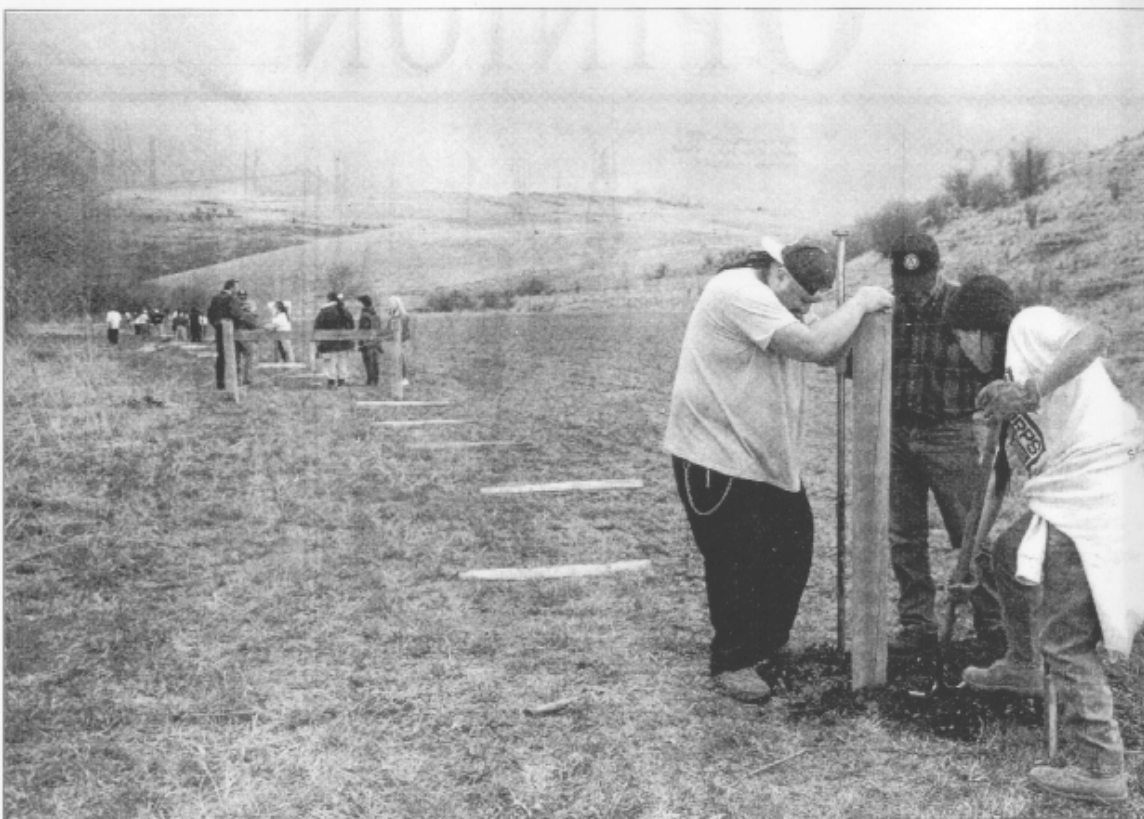
RIPARIAN WORK: Davina Spoonhunter fills a posthole as Phillip Smith and Tank James level a post for a fence line being installed by the Salmon Corps. All the workers are from Yakima, Wash.
